**SOUTHWESTERN COASTAL BASIN
GREENWICH, CONNECTICUT**

**AMERICAN FELT DAM
CT 00043**

**PHASE 1 INSPECTION REPORT
NATIONAL DAM INSPECTION PROGRAM**

FEBRUARY, 1980

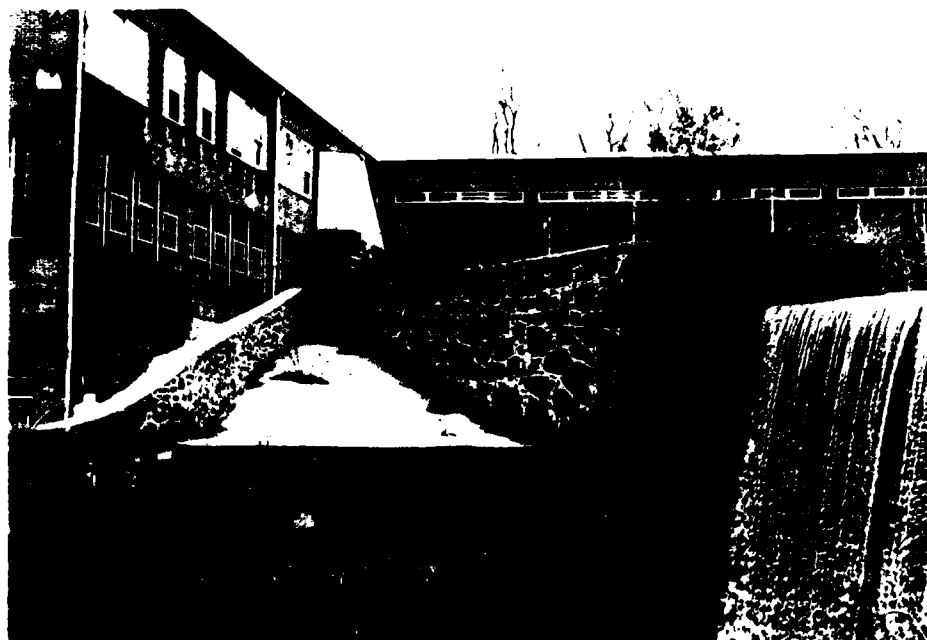
C-7 WEST OVERFLOW CHANNEL
